Assembling Çatalhöyük

The Architecture of Neolithic Çatalhöyük as a Process

Complexity in Apparent Simplicity

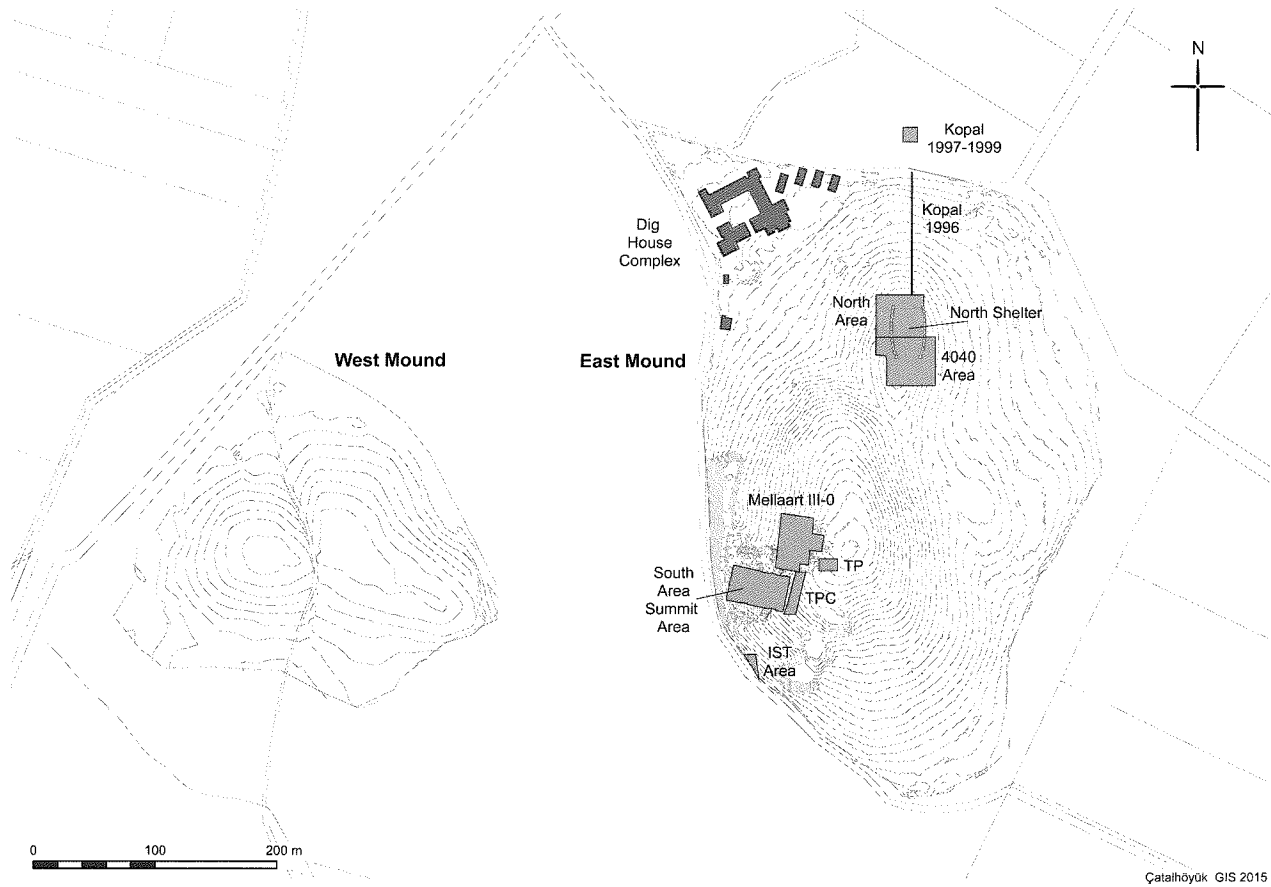
Figure 1. Overall plan of Çatalhöyük showing locations of the case study sequences. Figure created for the Çatalhöyük Research Project by Camilla Mazzucato.

Three case studies are presented to illustrate life cycles of buildings at Çatalhöyük. They are representative of different excavation areas and different occupational phases of the Neolithic settlement (Figure 1). Utmost attention is paid to specific and sometimes neglected issues including foundation of buildings, wall construction, premises of ceiling or roof structures as well as architectural deformations. All these contexts are described using architectural terminology and are argued to be an important source of information on stratigraphy, building materials, techniques and strategies, stability, and risk from natural hazards, as well as symbolic behaviour and ecology. Hence, they are valuable for any reconstruction of social dynamics within the Çatalhöyük community.

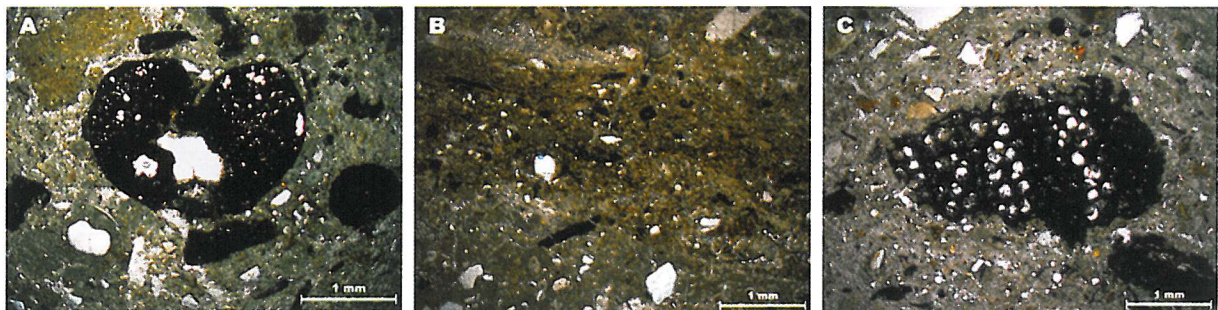
Figure 10. Microscopic features of ashy layers towards the top of roof/upper storey sequence: (a) charred seed, PPL; (b) charcoal-rich ashy microlayer on top of a poorly preserved fine plaster floor, PPL; (c) fragment of elm charcoal, PPL.

The top deposits in one of the sampled sequences include alternating layers of oven/heart rake-out containing charred cereal, deciduous woods, and burnt bones (Figure 10). It allows us to argue that cooking-related activities were performed on the uppermost part of the building. The increased accumulation of swept
